Inspection Report

Inspect It, Inc.

Date: 9/8/2012	Time: 01:00 PM	Report ID: 20120908
Property:	Customer:	Real Estate Professional:

Type of building:
Single Family (2 story)

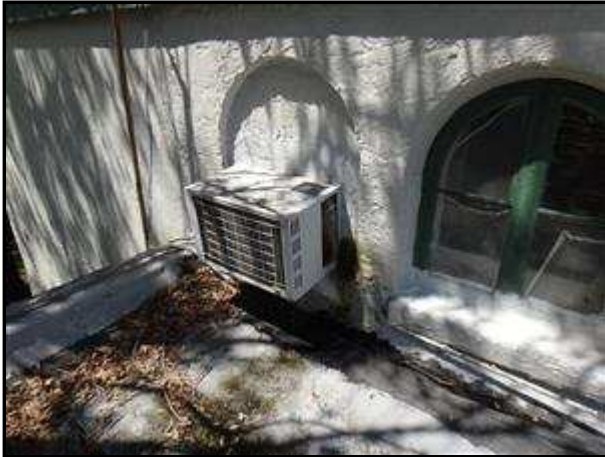
1.0 Picture 1

(Picture 1) Debris need to be removed. A/C should drain into an area where the water will not pool and reduce the life of the roof covering.

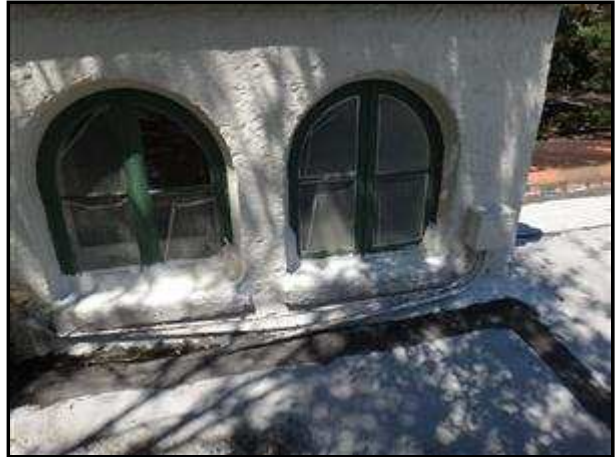
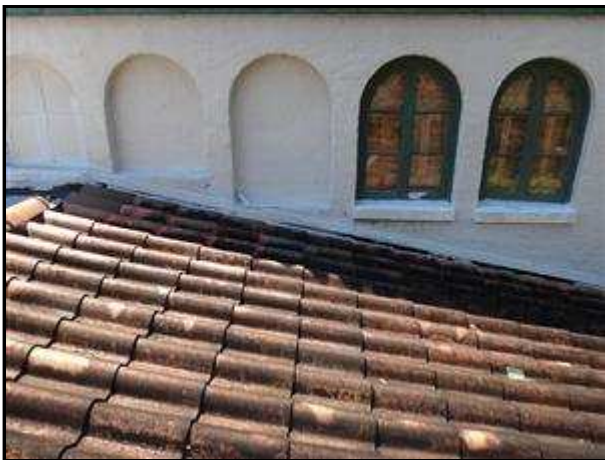
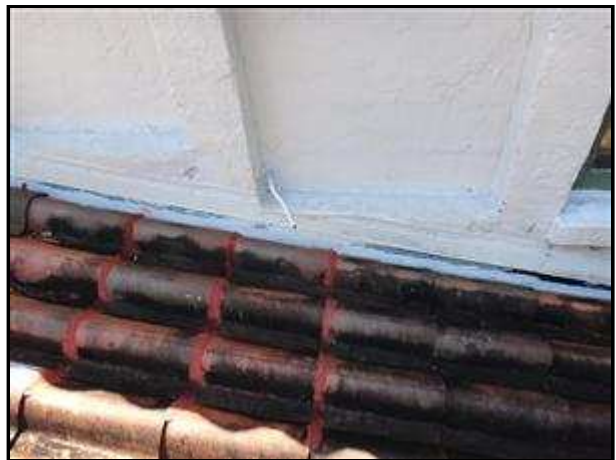
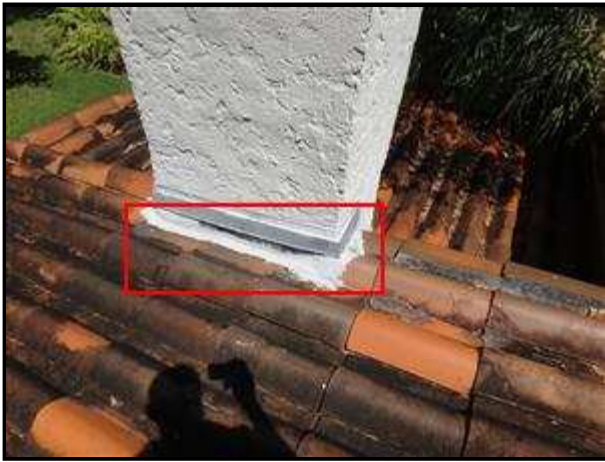
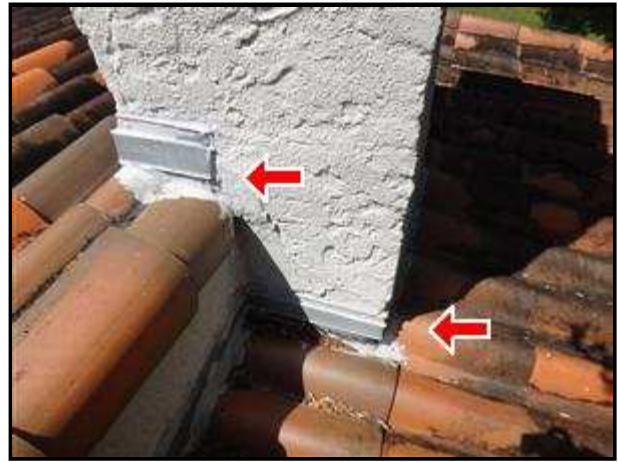
(Picture 2 - 6) Recent repairs are visible.

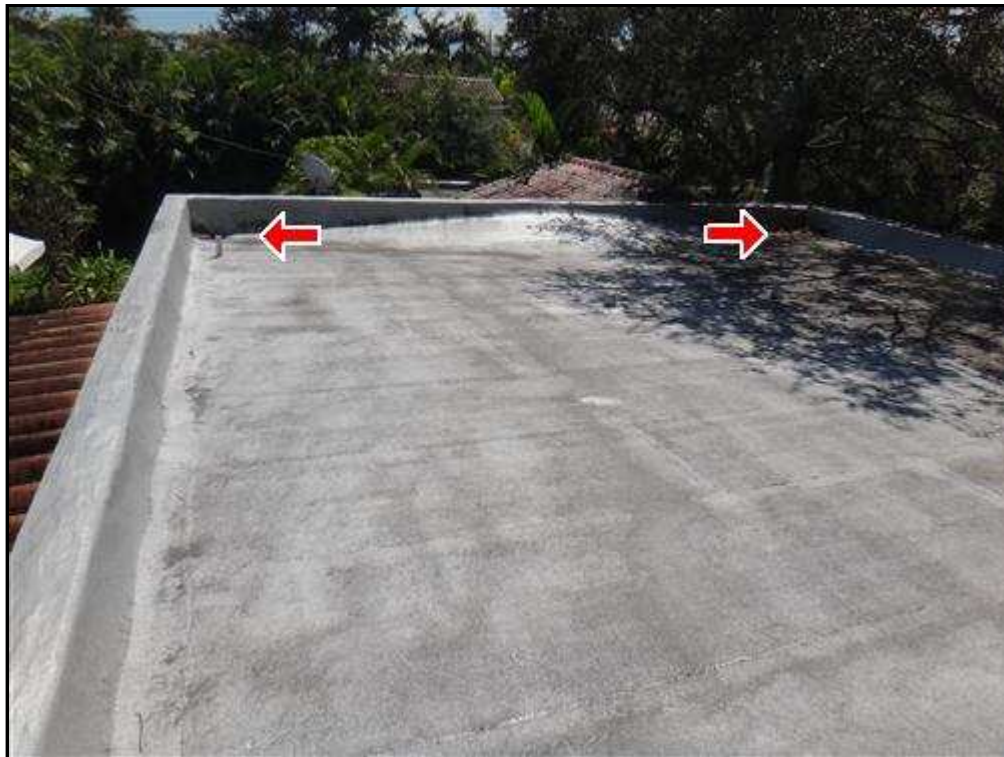
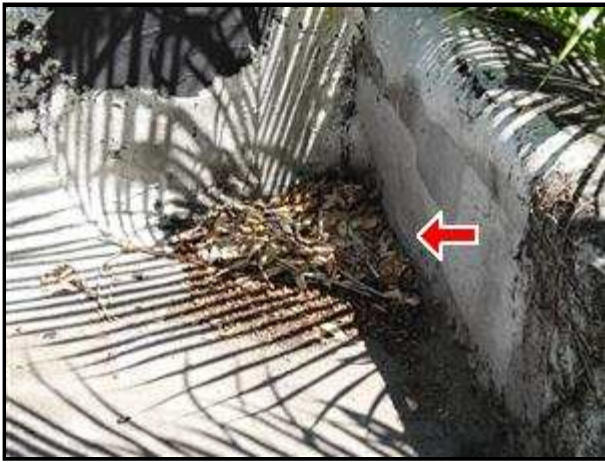
(Picture 1 & 2) Main house flat roofing system is not draining properly because the drainage holes are clogged with debris and need to be cleaned. (Picture 3) Directly below the South East drain there is the Kitchen window area that is showing signs of water intrusion.

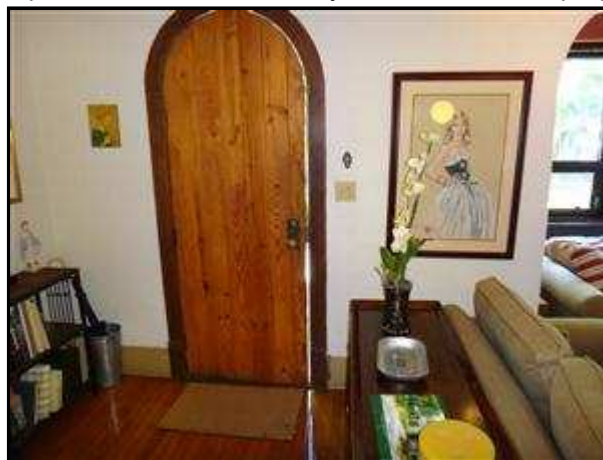
2.1 Picture 1

(Picture 1) Door is difficult to open/close. Latch assembly does not function properly.

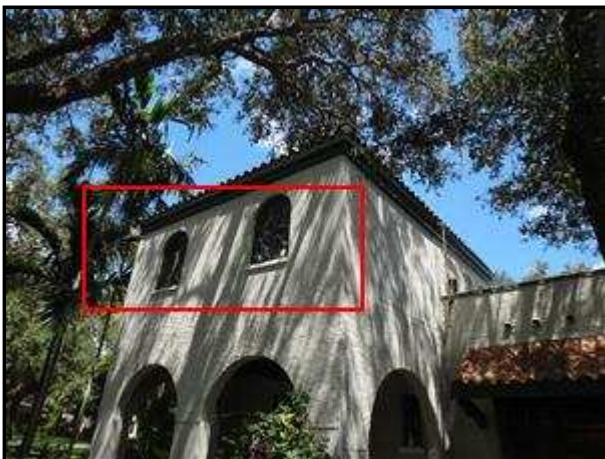
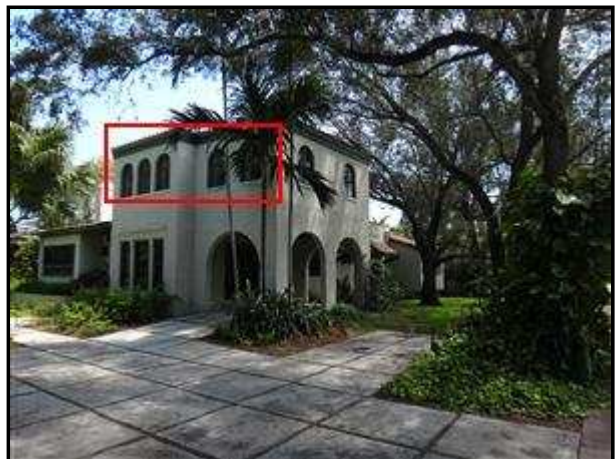
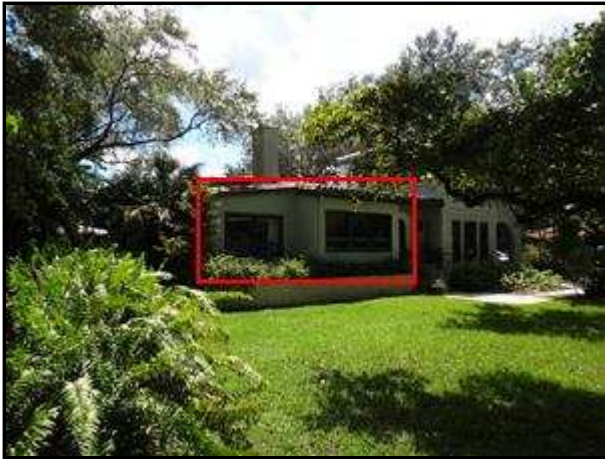
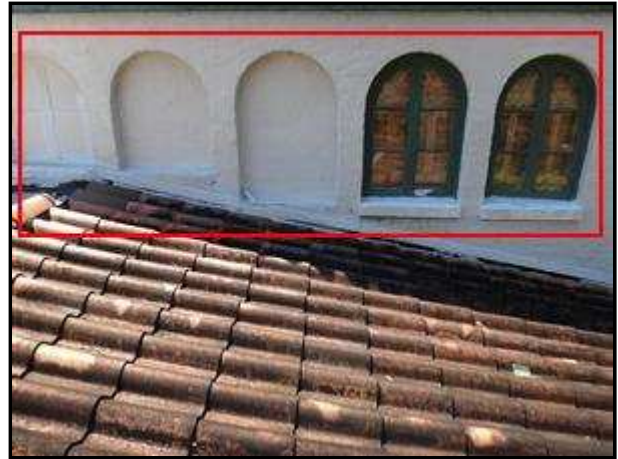
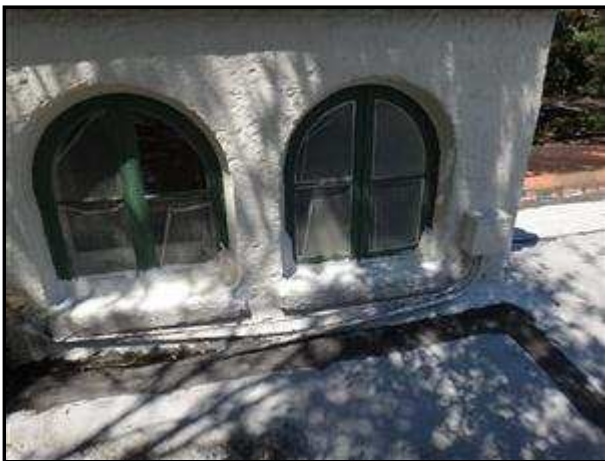
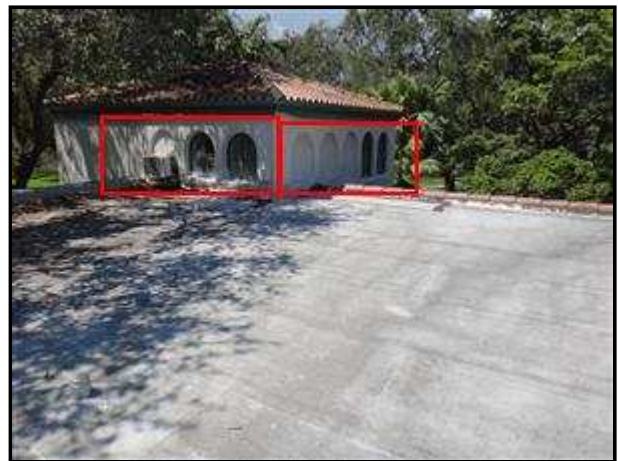
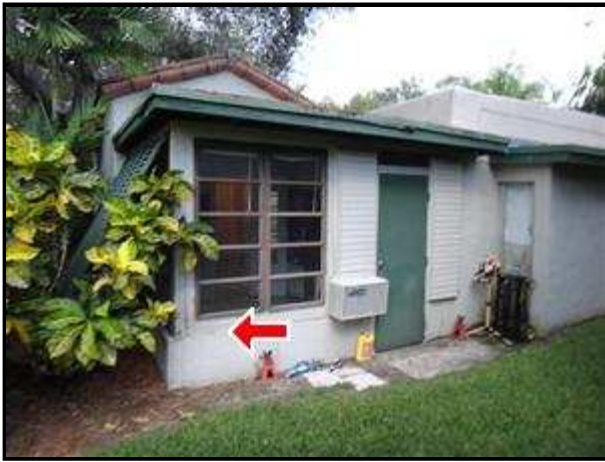
(Picture 1 - 8) Several windows that appear to be original or aged, have had and will require maintenance to keep water intrusion from happening. The wood framing around these windows has visible rot/deterioration.

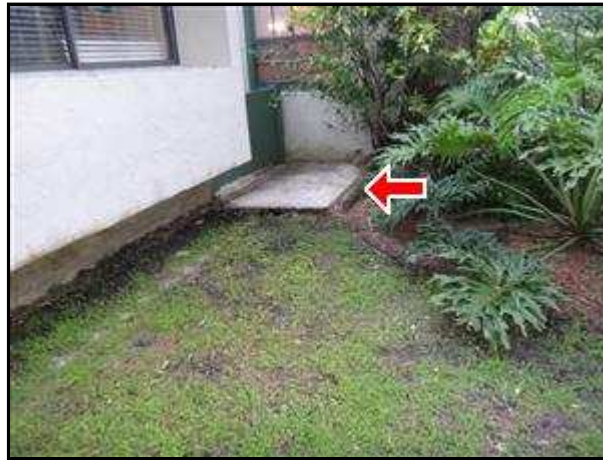
2.3 Picture 1

(Picture 1) Concrete walkway is lifting and is a trip hazard.

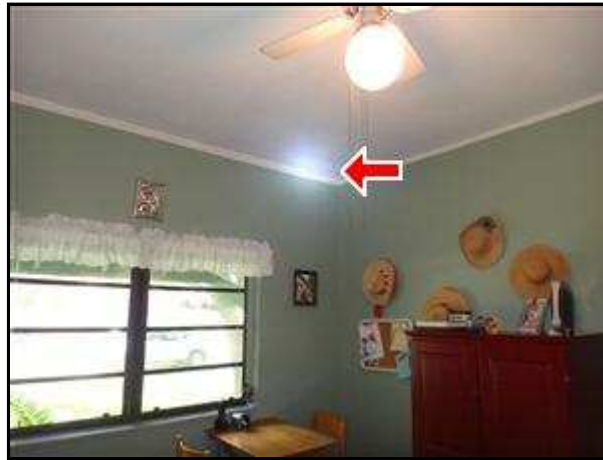
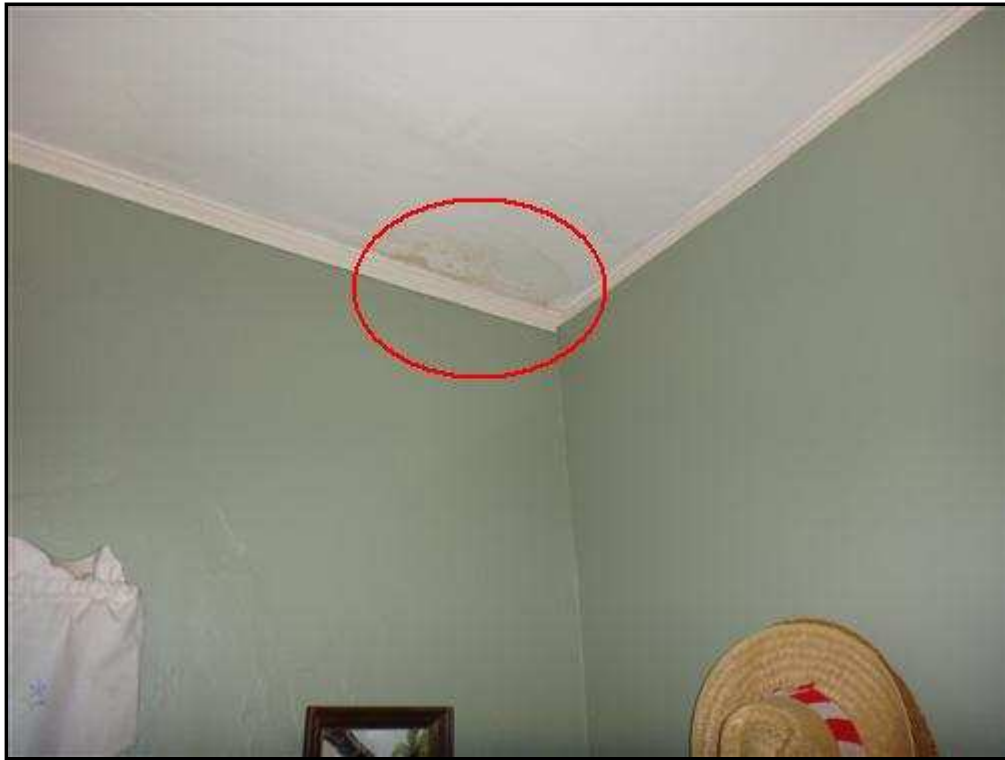
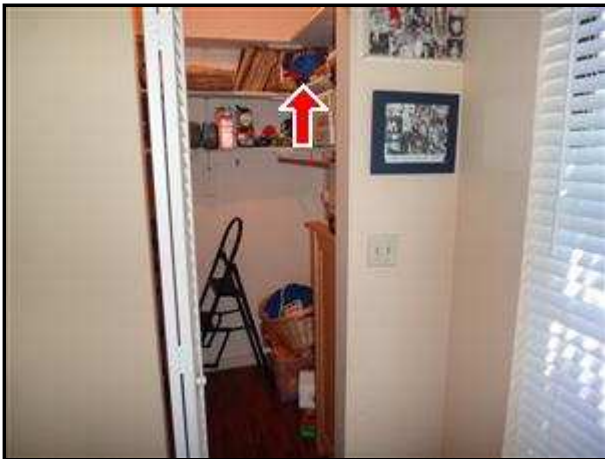
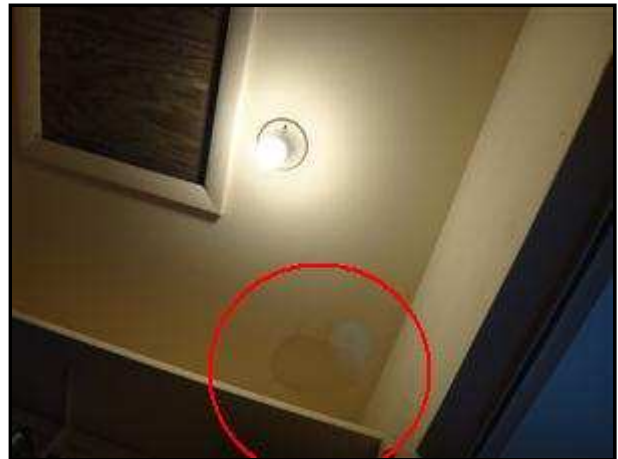
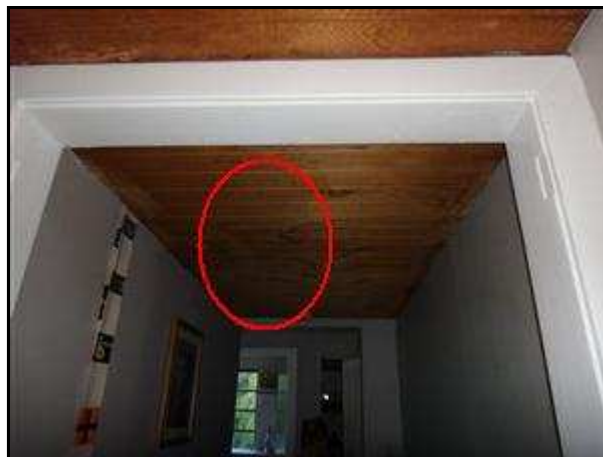
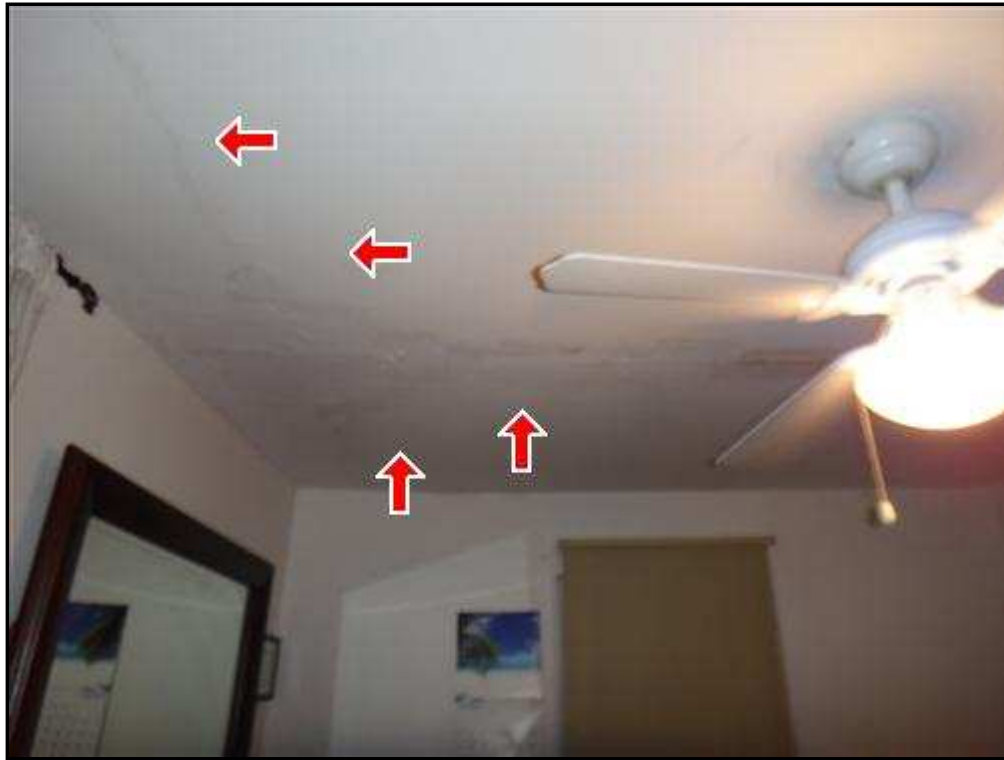
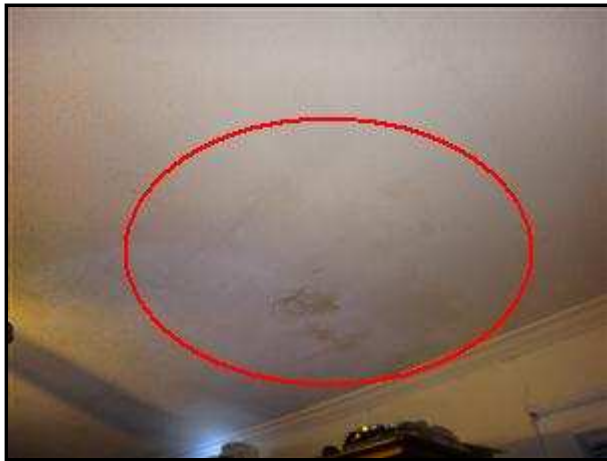
(Picture 1 - 7) Moisture stains were visible in some areas. No moisture was present at time of the home inspection. Due to the design of the home, having a crawlspace makes it easier for the water to drain off and evaporate quicker in the wall or attic areas than a more recently built home, making it difficult some times to correctly diagnose an active water leak from a non active water leak. These areas may require further investigation.

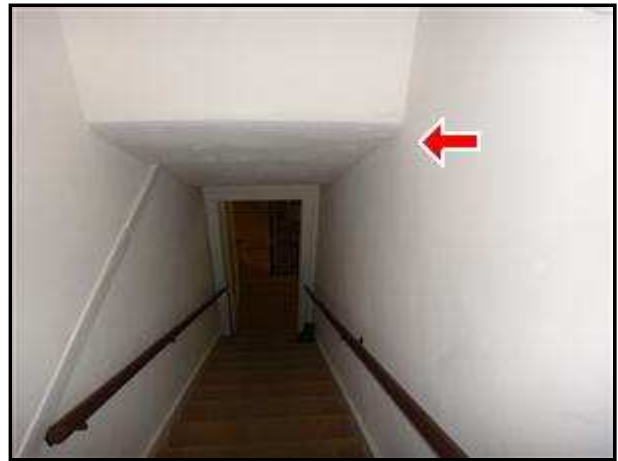
3.0 Picture 8

(Picture 8) Ceiling is very low at the stairway to the master suite.

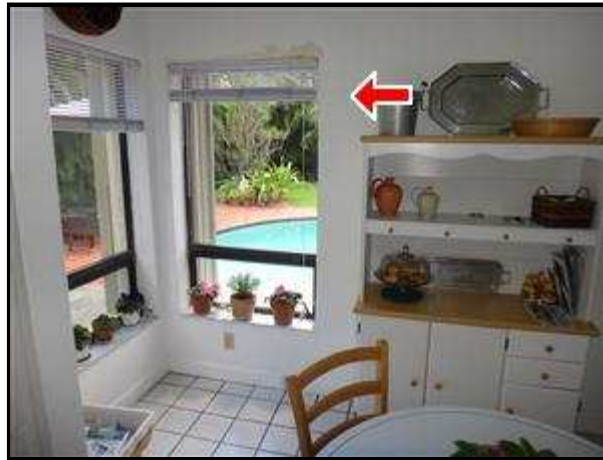
3.1 Picture 1

(Picture 1) This window is below one of the clogged drain holes for the roof. There is moisture damage visible. No moisture was present at the time of the inspection.

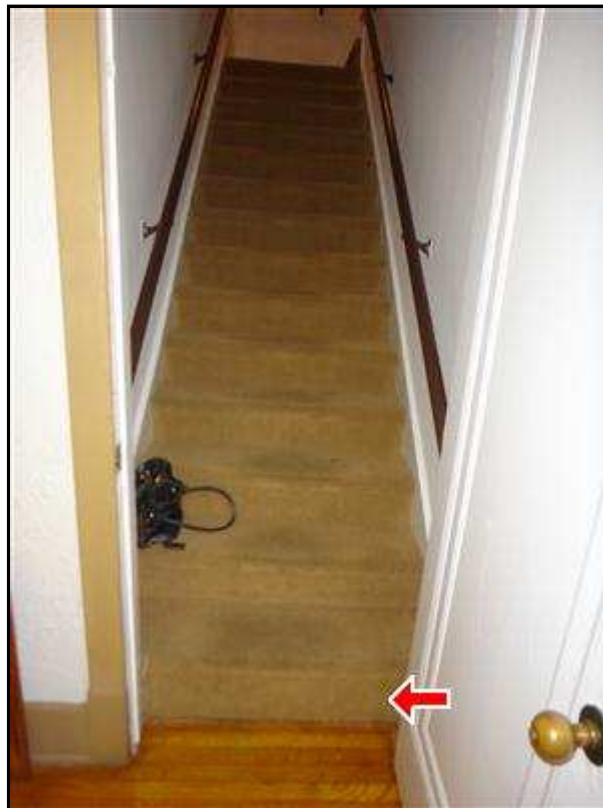
3.3 Picture 1

(Picture 1) The first step is not uniform with the rest of the stairs. This is a trip hazard.

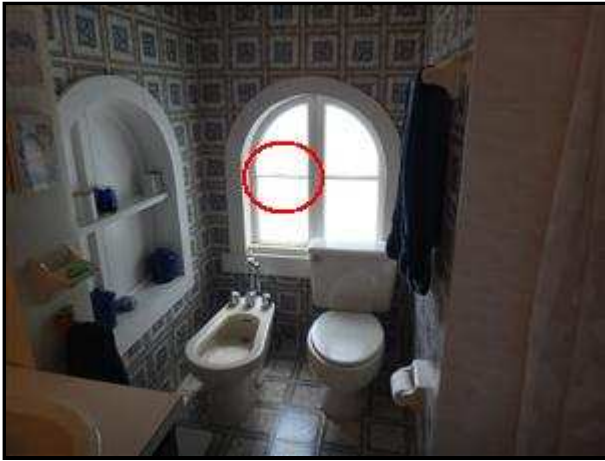
3.6 Picture 1

(Picture 1) Master bathroom window is cracked.

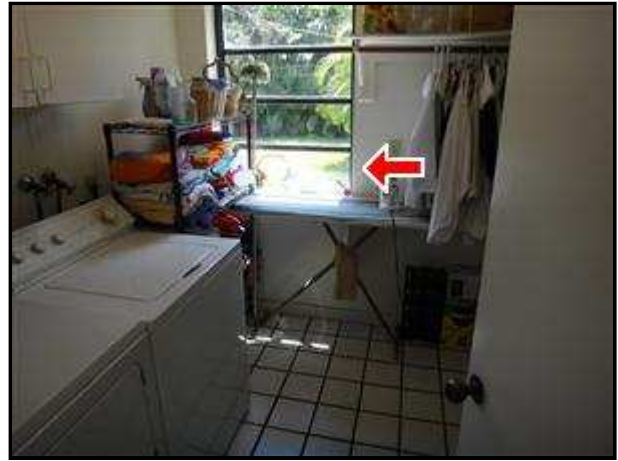
3.6 Picture 2

(Picture 2) Laundry room window would not close completely.

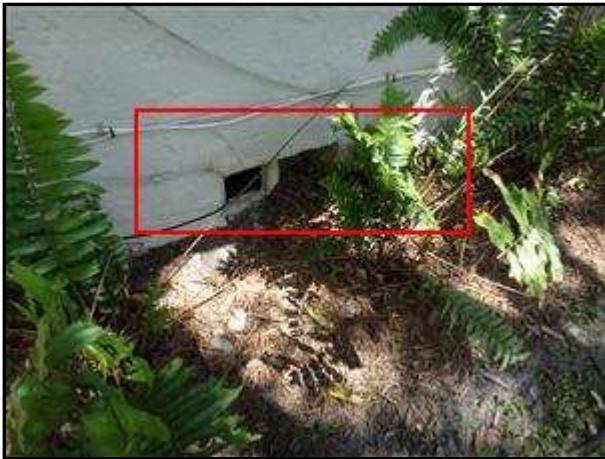
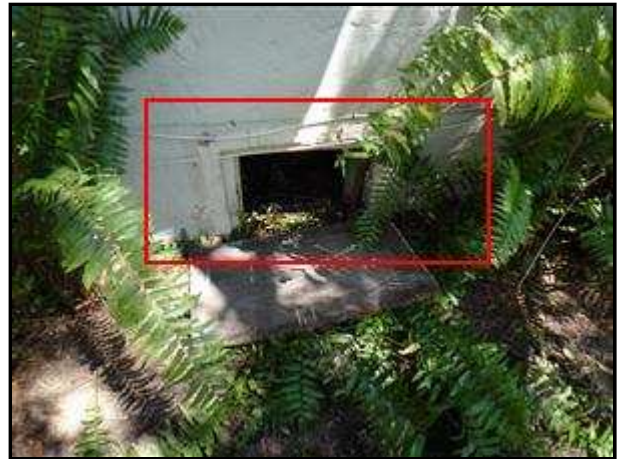
(Picture 1 & 3) Crawlspace needs vent screening over access holes to prevent animals/pests and debris from entering, and at the same time, maintaining sufficient ventilation. Many ventilation areas of the crawlspace have been blocked with additions. There is evidence of elevated moisture in the crawlspace over time.

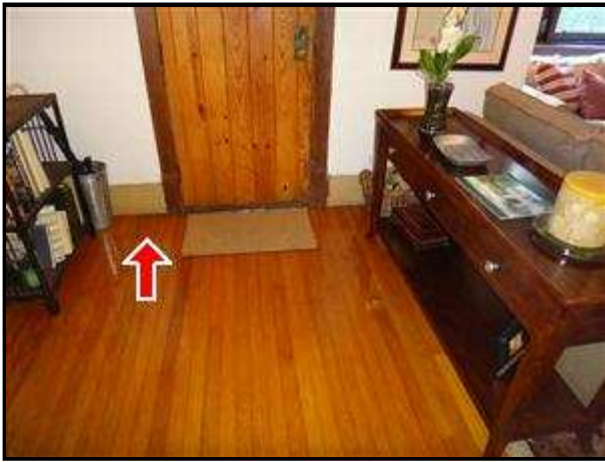
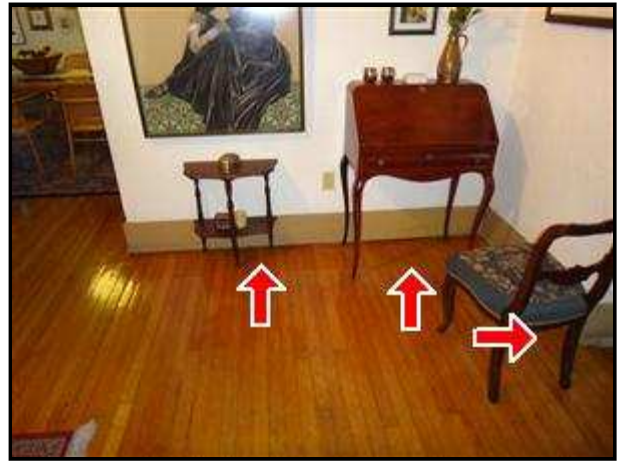
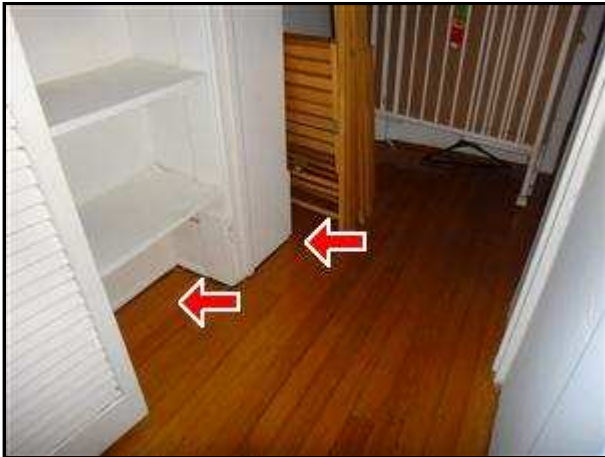
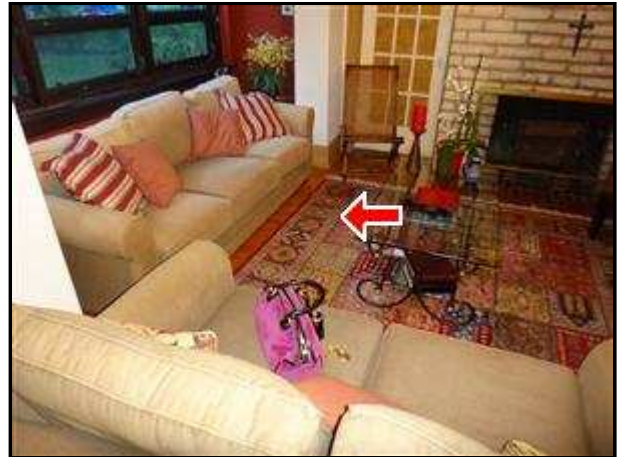
(Picture 1 - 4) As discussed during the home inspection, there are several areas of the floor that are sagging.

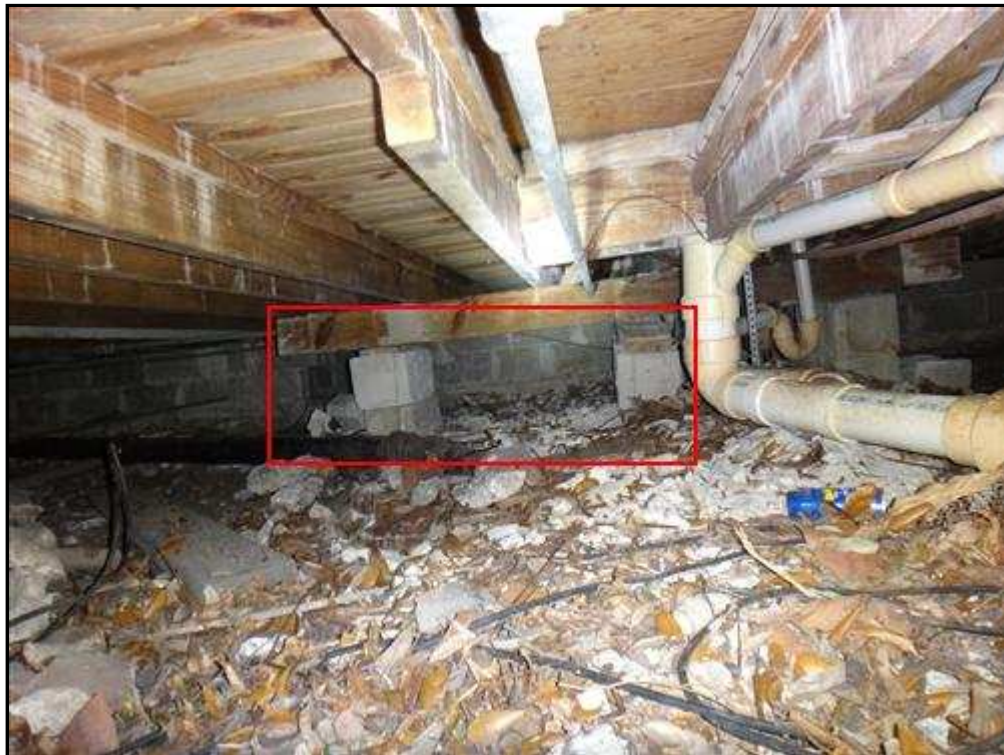
4.2 Picture 5

(Picture 5) There has been some structural support added in the crawlspace that appears to be compromised at time of inspection.

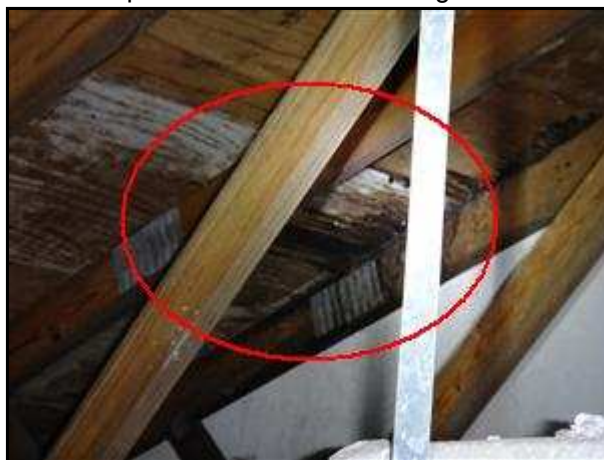
4.4 Picture 1

(Picture 1) There is a visible moisture stains/damage in the attic space over the rear of the main house. No moisture was present at time of the inspection. The roof sheathing in this area is rotted.

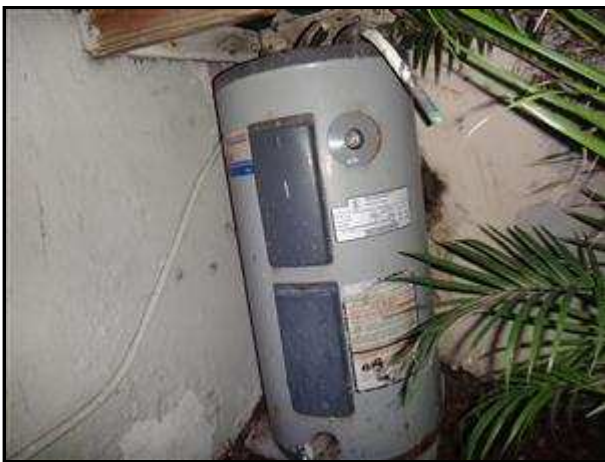
(Picture 1) Heater is not installed to local codes and is not designed to be installed outside.

5.2 Picture 1 Guest house water heater

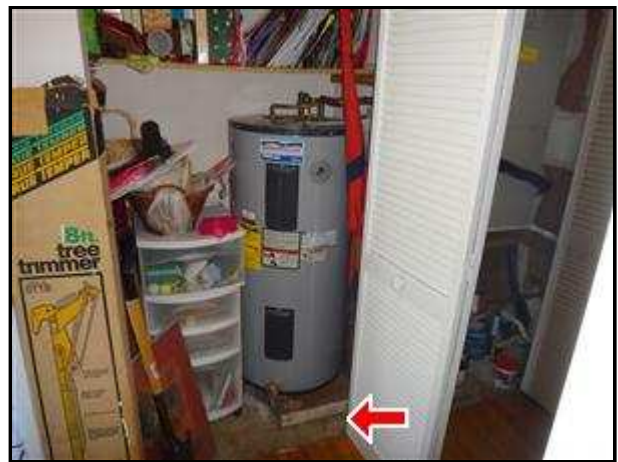
(Picture 2) Heater is not supported correctly. Stand is too small for this heater.

5.2 Picture 2 Main house

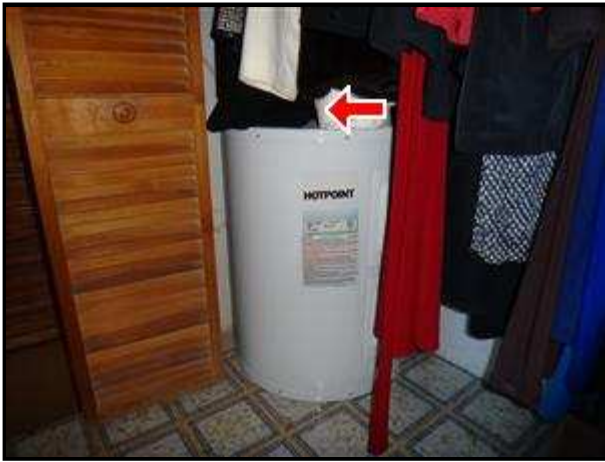
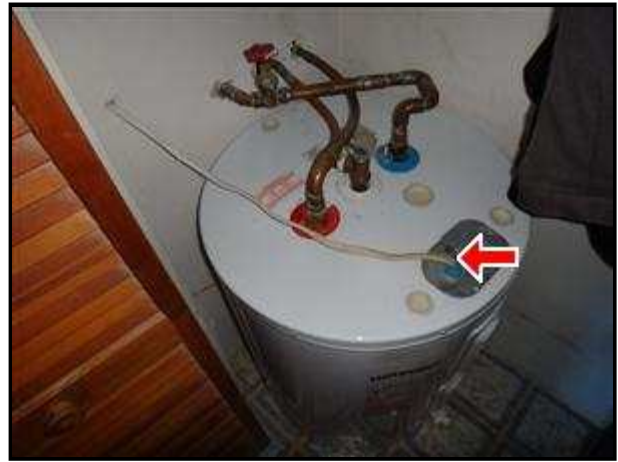
(Picture 3 & 4) Heater electrical wiring should be in protective sheathing.

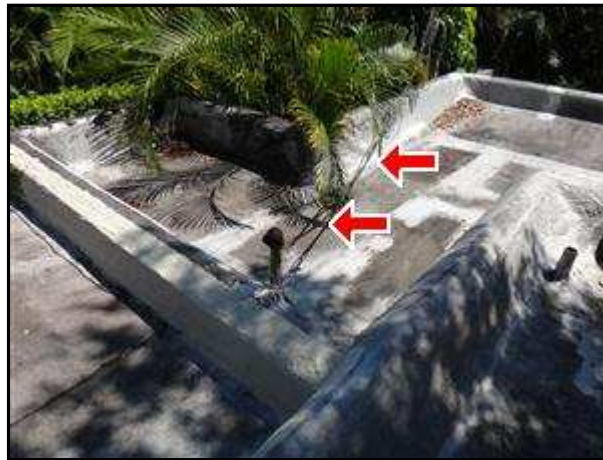
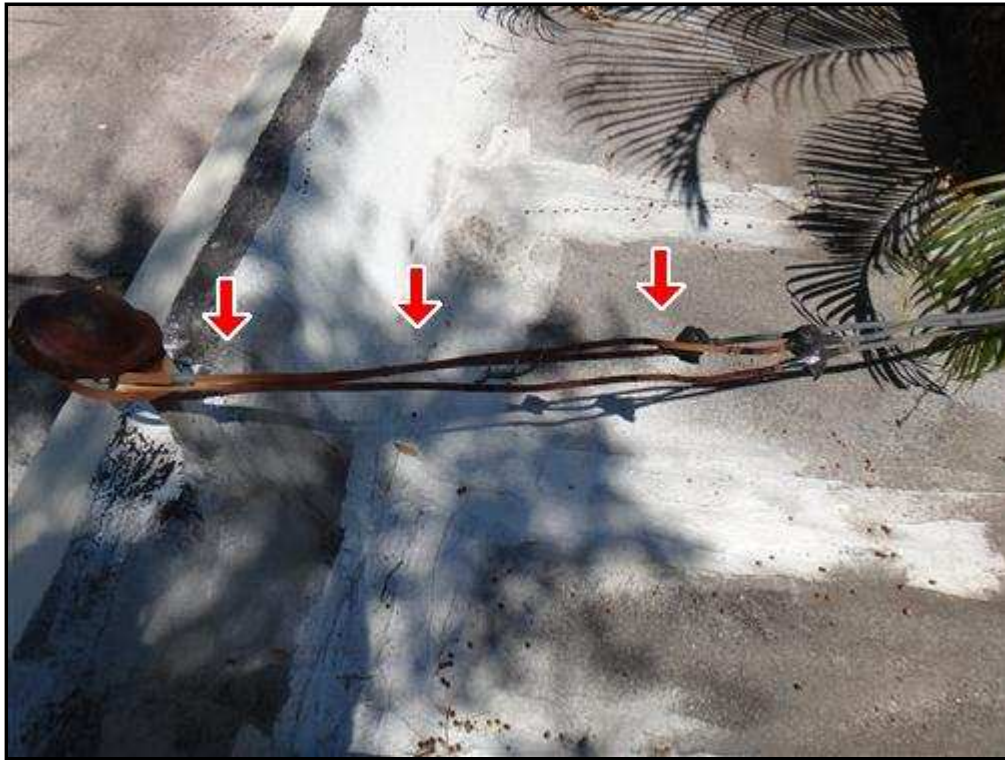
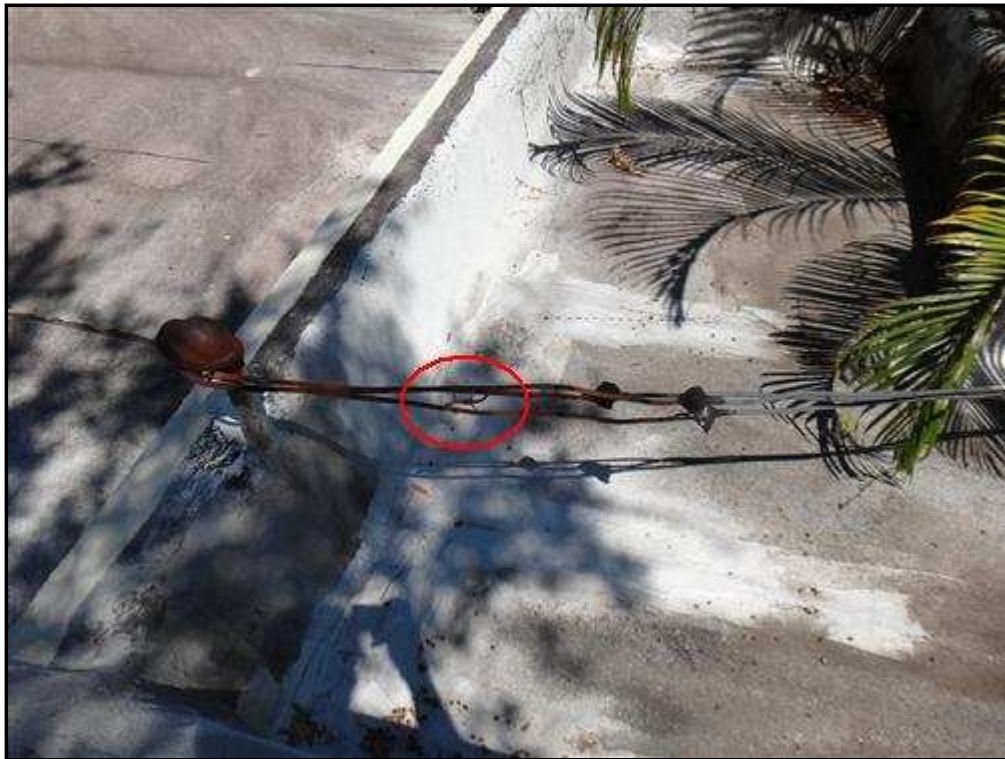
(Picture 1 - 3) The protective sheathing over the wires is weathered. It also appears to be not enough slack in the wire to prevent damage. It is too close to the roof surface to allow the proper amount of slack needed to prevent damage.

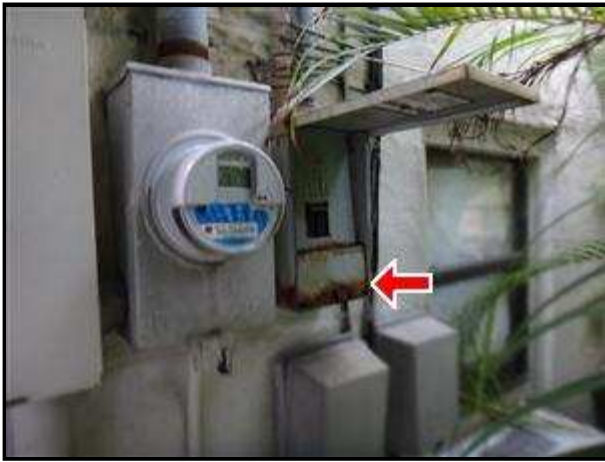
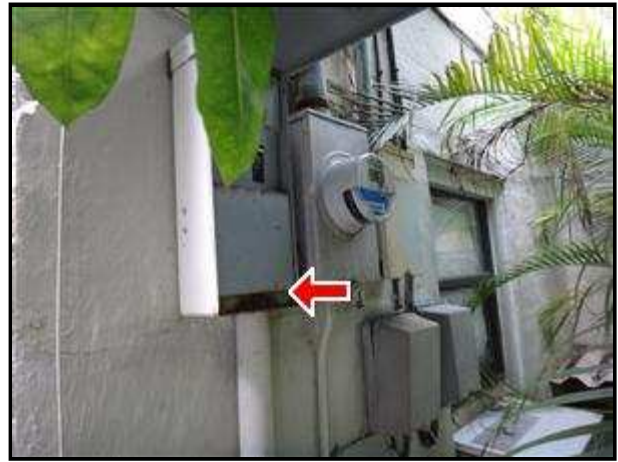
(Picture 1 & 2) Main panel service panels are rusted/corroded.

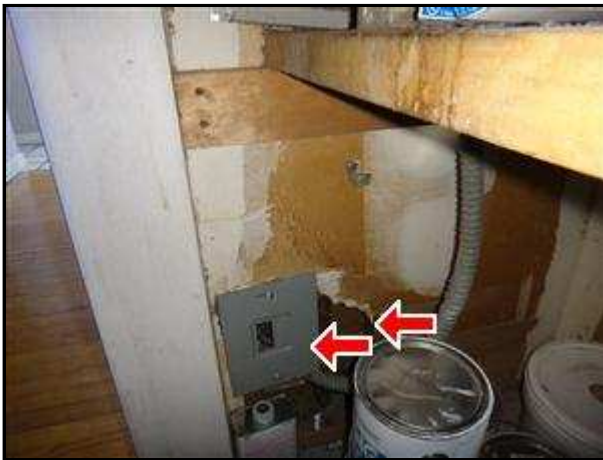
(Picture 1) Drywall is damaged in closet. Disconnect box has been bypassed and there is no disconnect present.

7.2 Picture 1 A/C closet

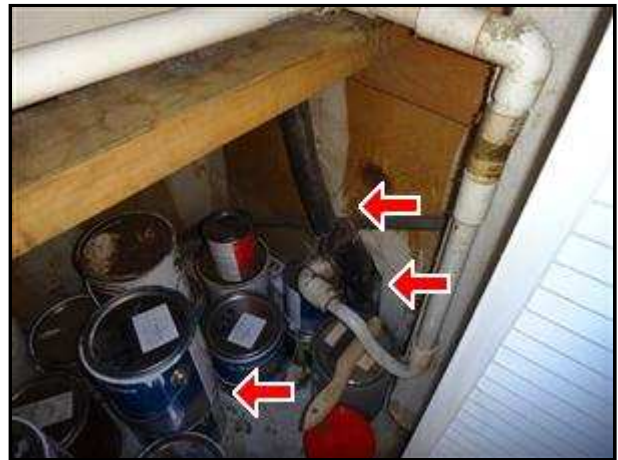
(Picture 2) Drywall is damaged in closet, Copper piping insulation is deteriorated, and paint cans should not be stored near the a/c return.

7.2 Picture 2 A/C closet
